# DIESEL POWER

# HARDHEADED

## FORD 6.0L CYLINDER HEAD REPAIR MADE EASY

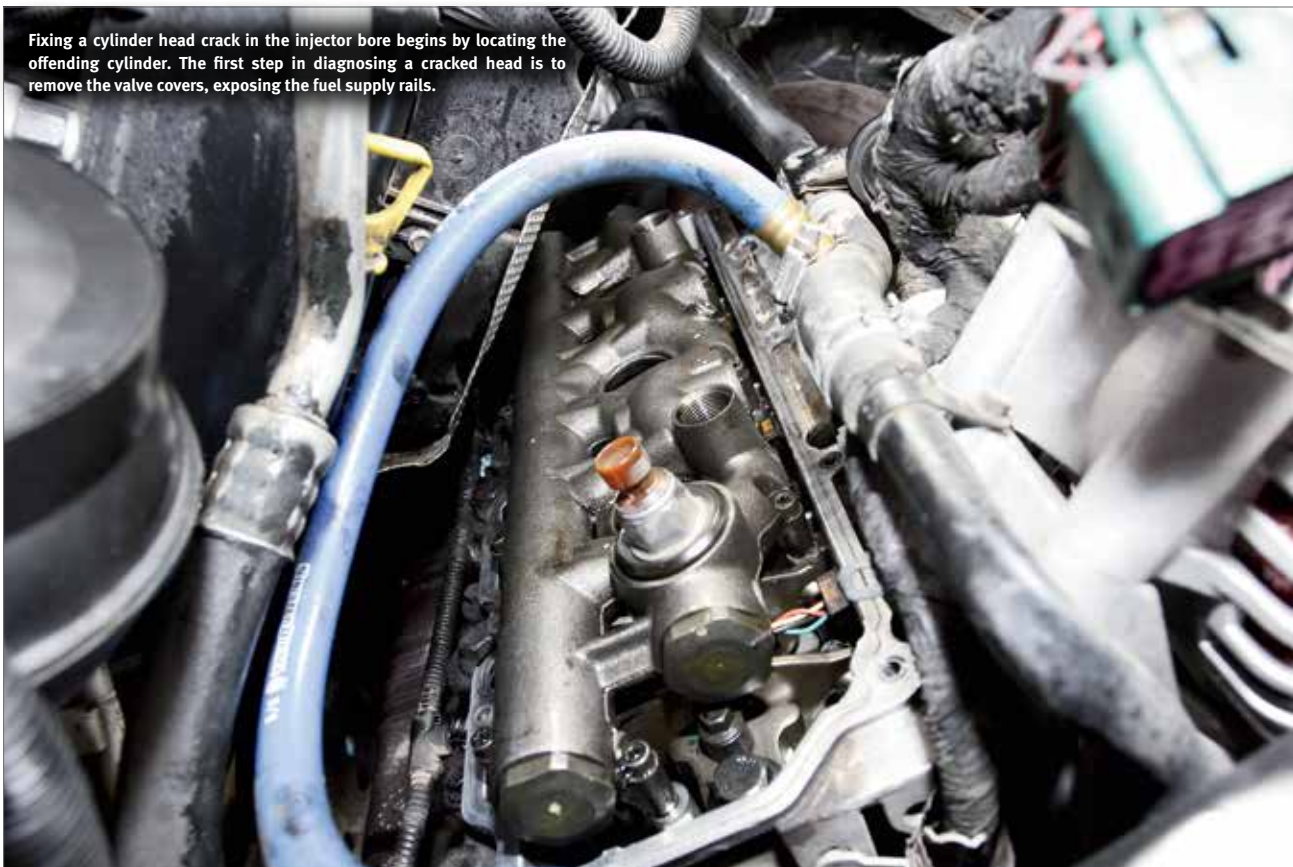
Fixing a cylinder head crack in the injector bore begins by locating the offending cylinder. The first step in diagnosing a cracked head is to remove the valve covers, exposing the fuel supply rails.

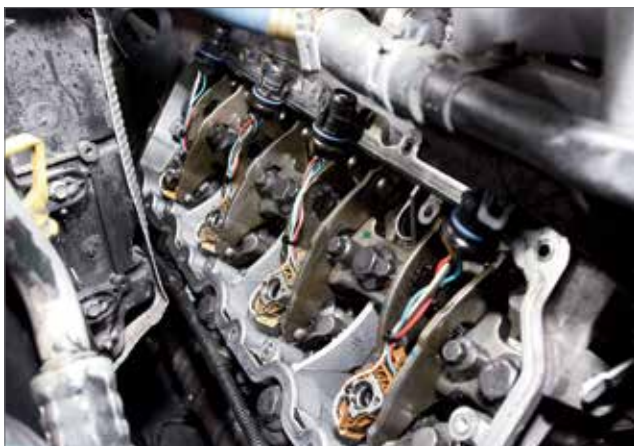
With the fuel rails removed, technician Delwin Wamsley gets to work, carefully pulling each of the eight injectors. Special attention should be paid to remembering the specific cylinder each injector belongs to.

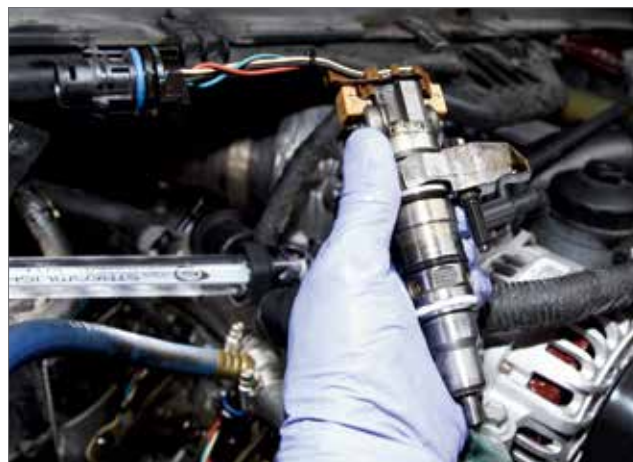
Each injector is inspected for signs of wear and then placed aside along with its individual holder. A clean working surface is vital to preventing contamination of the fuel injectors.

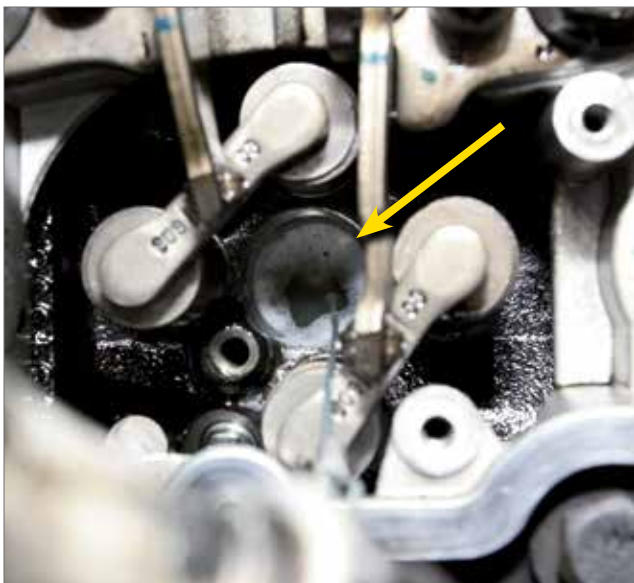
With all eight injectors removed, rubber stoppers are placed in the injector bores and they are then filled with WD-40. Delwin allows the bubbles to disperse before moving on to the next step.

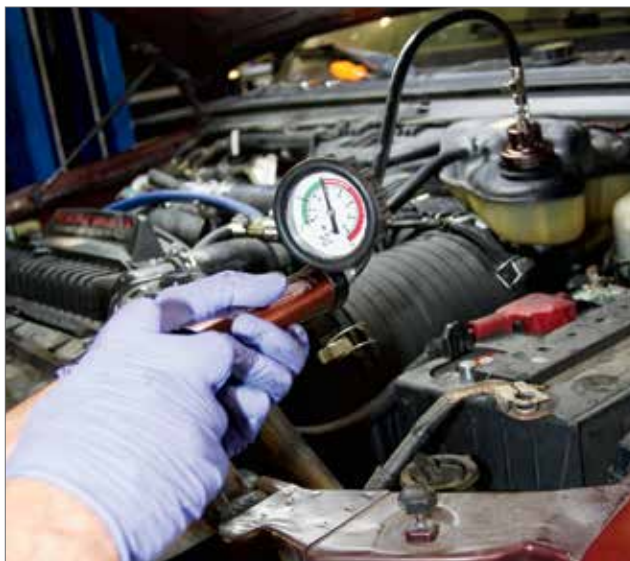
Once the bubbles in the WD-40 subside, the coolant system is drained and then pressurized to 15 psi using a hand pump and the truck's degas bottle. Finding the offending cylinder is as simple as seeing which injector bores are bubbling from the pressurized cooling system.

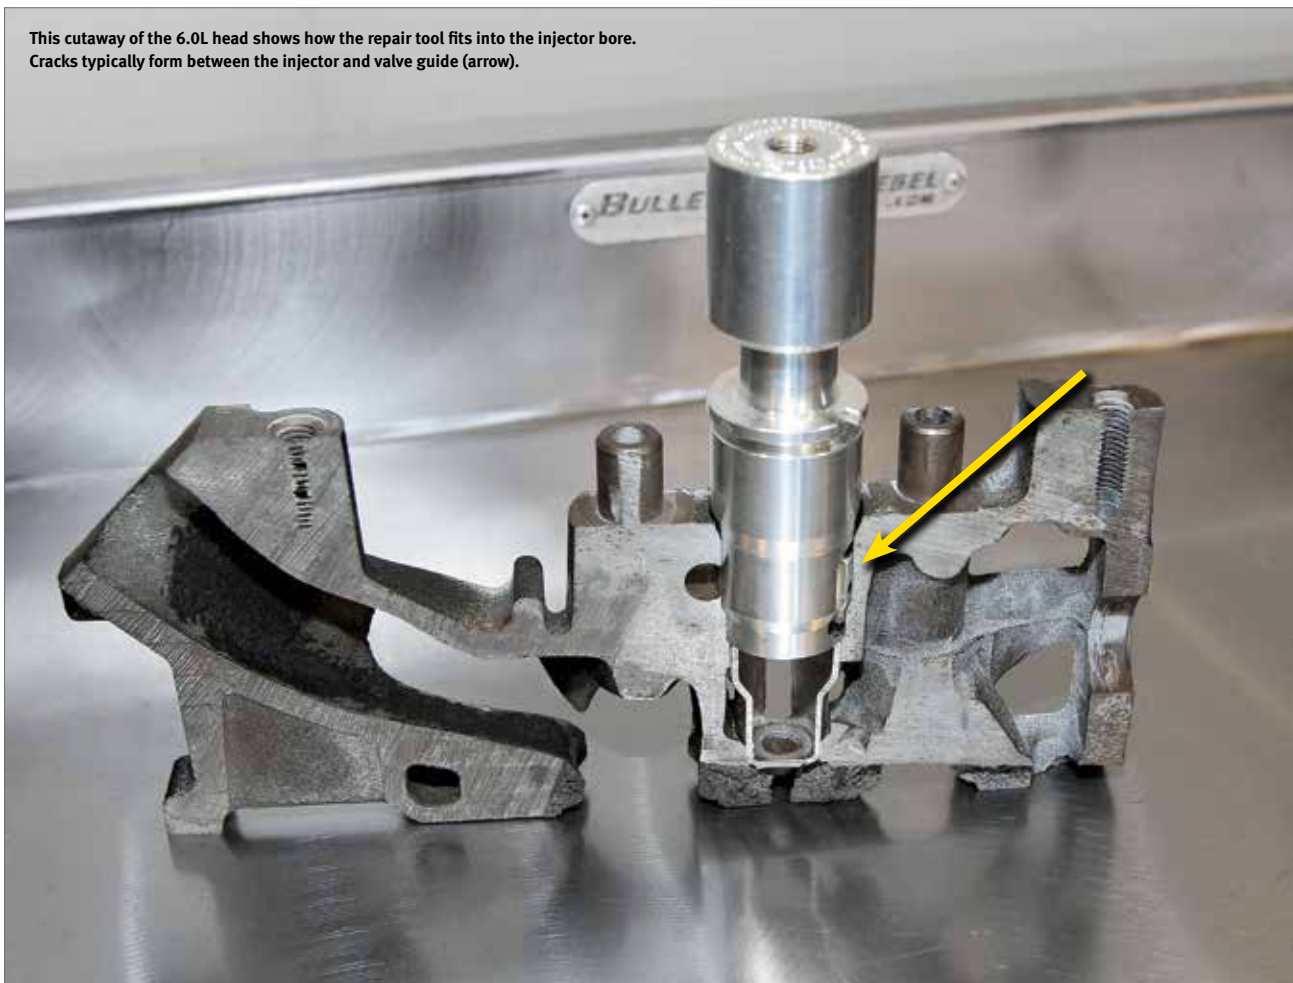
This cutaway of the 6.0L head shows how the repair tool fits into the injector bore. Cracks typically form between the injector and valve guide (arrow).
