SAY NO TO CRACKS

An Innovative Fix For A Cracked 6.0 Cylinder Head

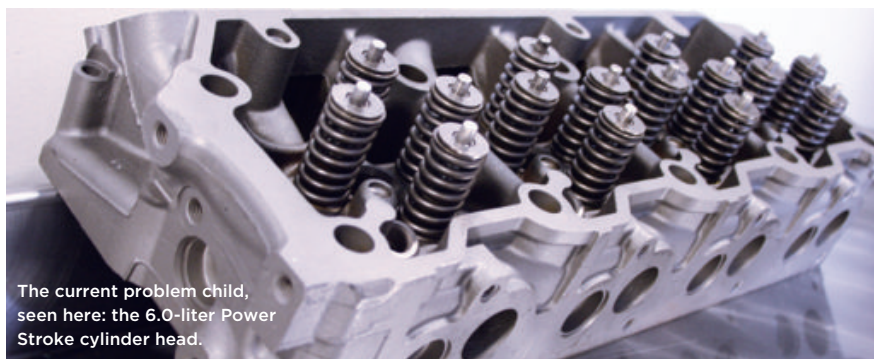
The current problem child, seen here: the 6.0-liter Power Stroke cylinder head.

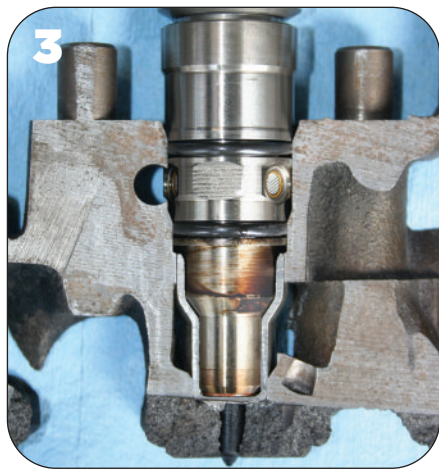
This photo shows where the damage occurs. Fuel enters from the fuel rail (the circular opening at the left), and the crack is on the right, above the injector cup. Mechanics familiar with the 7.3 may misdiagnose the problem as a broken injector cup. On the 6.0 engines, the cracks occur in the head, above the cup.

Mechanics who are familiar with the 7.3-liter Power Stroke engine often diagnose fuel in the coolant as a cracked injector cup (the metal insert between the injector and the head). While cracked injector cups are a problem on the 7.3, Bullet Proof has yet to find a 6.0 with a cracked cup. The cracks occur in the head, at or above the top of the cup.

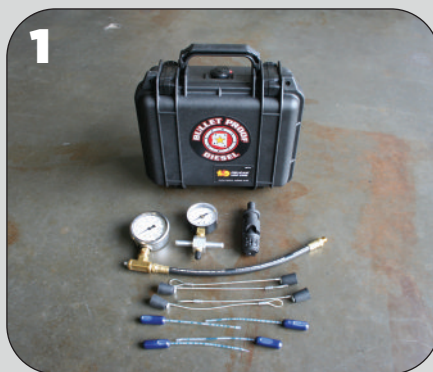
The complete kit includes the repair tool, testing stoppers, grease gun pressure gauge, and four pipettes of sealant, all packaged in a durable Pelican case.

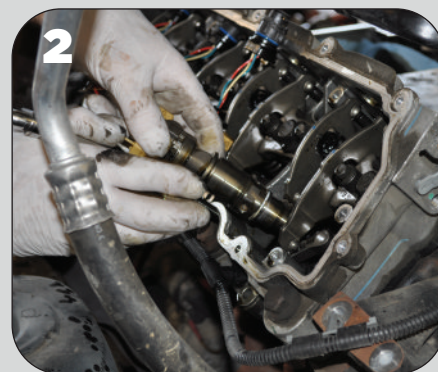
Repair starts by draining the radiator and removing the block plugs to drain coolant from the engine. The cooling system must be completely drained. Next, remove all eight fuel injectors following the procedure in the Ford service manual.

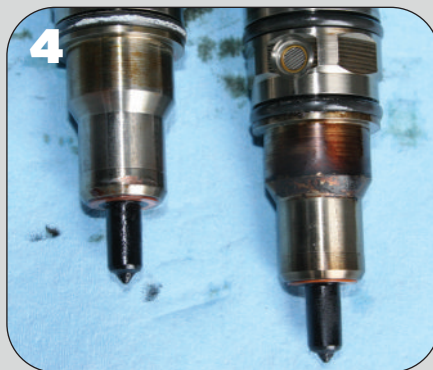
If the crack has extended below the lower injector O-ring, the injectors themselves may give some clue as to the location of the leak. The injector on the left has a small rust stain near the tip, which indicates contact with coolant pooled in the bore. The residue on the injector at right is from coolant-contaminated fuel, and may indicate a leak upstream (i.e., a lower cylinder number). Clean injectors do not indicate lack of a leak; you still need to pressure-test.

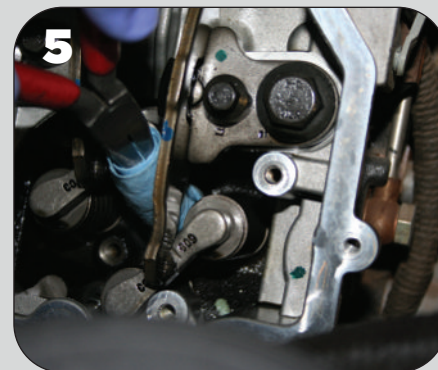
Clean the cylinder heads using a dry shop towel. Vertical marks (perpendicular to the bore) on the exhaust manifold side of the bore are indicators of a crack; machining marks for the bores run parallel to the plane of the cylinder head.

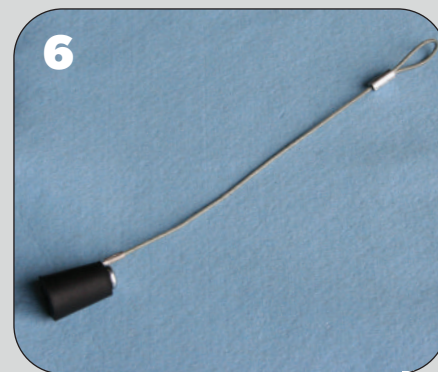
Testing is performed on one cylinder at a time. Cracks may exist in more than one cylinder, so be sure to test all eight. Install the four rubber stoppers, which are included with the kit, into the injector bores on one side of the engine. Reinstall all parts removed to drain the coolant (block plugs, petcocks, etc.) so that the cooling system can be pressurized.

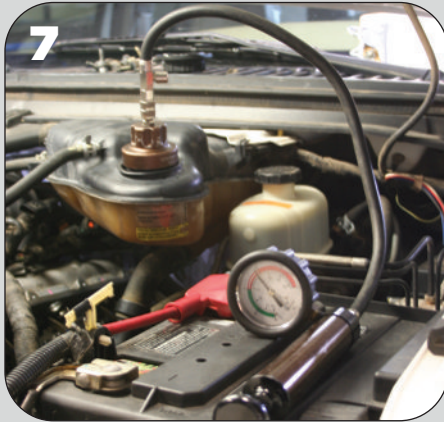
Using a coolant system pressure tester, pressurize the cooling system to 20 psi.

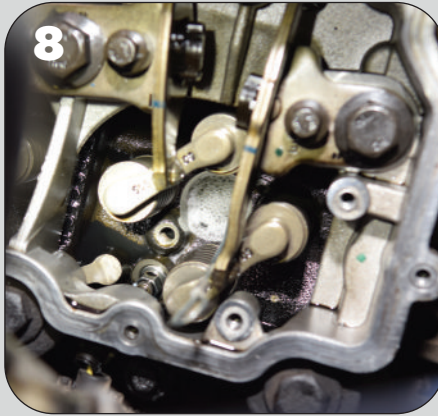
One by one, fill the plugged injector bores with WD-40 and allow it to settle. Now comes the part that requires patience. Look for bubbles coming from the exhaust manifold side of the bore. An inspection mirror will be helpful for the rear cylinders. Cracks are most commonly found in cylinder number five (second from the rear on the passenger's side), but Bullet Proof has found cracks in all eight cylinders. Once the cracks have been found, sponge out the WD-40, again using dry shop towels. You are now ready to begin the repair!

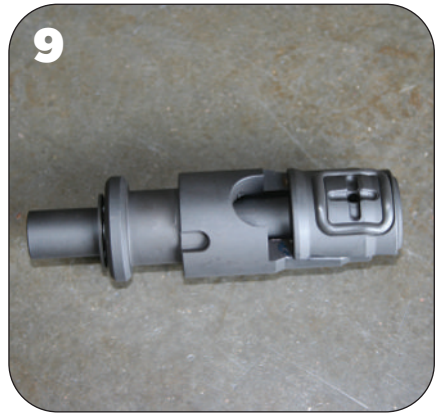
This specially designed tool is used to deliver sealant to the cylinder head cracks.

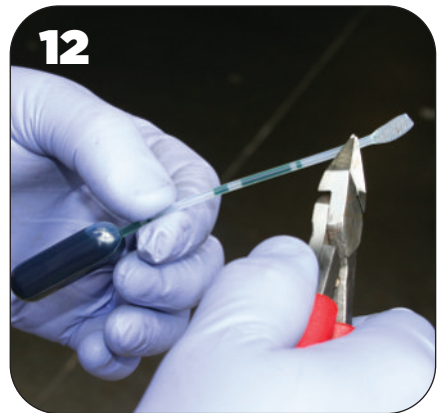
The sealant is packaged in a sealed plastic pipette. Four are provided with the kit, and additional sealant can be ordered from Bullet Proof Diesel.

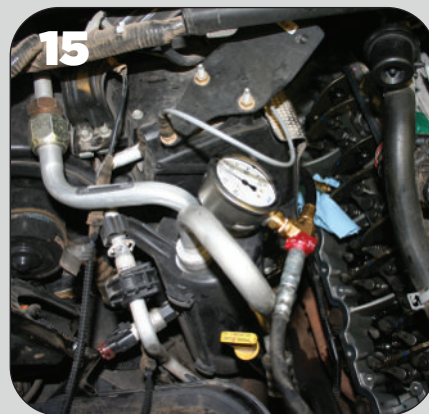
Watch the gauge for 10 to 15 minutes. The pressure should drop slowly. No pressure drop indicates that either there's no crack at that cylinder or the tool is improperly installed.
