BY JEREMY COOK
PHOTOGRAPHY: JEREMY COOK

Bulletproof Your 6.0L Diesel

Making a Ford Power Stroke Last Damn Near Forever

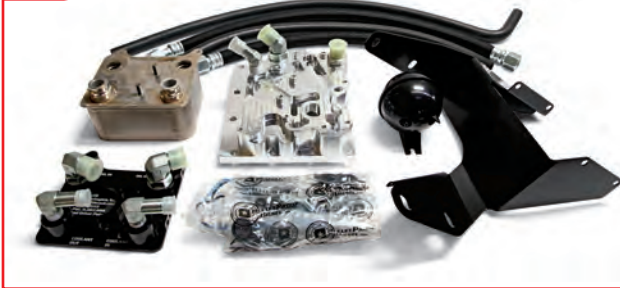
1. The first on our comprehensive list of improvements is the Bullet Proof Diesel OEM-style Oil Cooler Remote Mount Kit (PN VK688). This kit makes it possible to remote mount the stock engine oil cooler, which is normally located down in the valley between the cylinder banks. This makes the once-daunting task of replacing the oil cooler a simple affair.

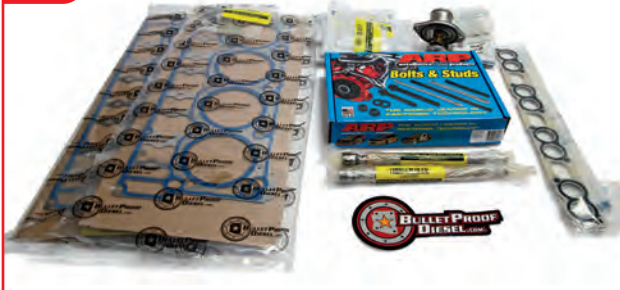
3. Since our upgrades required taking the top end down to the heads anyway, we decided to stud the block, using the complete Head Gasket Install Kit from Bullet Proof Diesel. This kit comes with all the required parts to replace your head gaskets—most importantly, the ARP head studs.

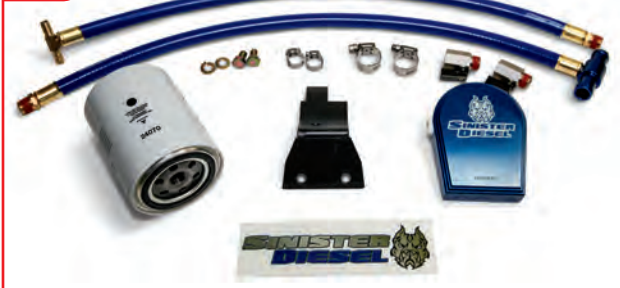
5. Sinister Diesel's Water Coolant Filter Bypass System (PN SD-COOLFIL-6.0) removes any contaminants in the coolant system adding extended life to your water pump, EGR cooler, and engine oil cooler.

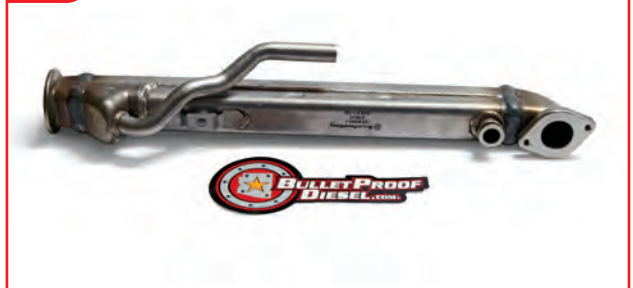
2. Most 6.0L experts agree that if you only make one upgrade to your truck, this is it. Whether your truck requires the round or square version of Bullet Proof Diesel's lifetime warranty EGR Cooler (PN NT-EGRC-1), they utilize stainless tubing instead of fins to minimize fatigue and heat stress failure and is fully TIG-welded.

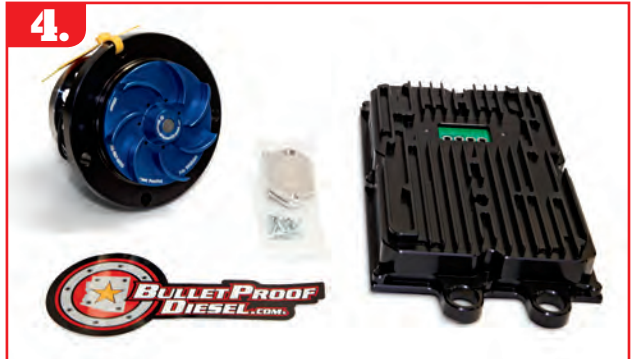
4. Rounding out the bevy of Bullet Proof Diesel parts is their Billet Water Pump that includes an upgraded billet housing to replace the stock plastic unit. Last but not least was the Bullet Proof Diesel FICM (fuel injection control module) that features an updated, rugged circuit board and a billet aluminum finned case to better dissipate heat.

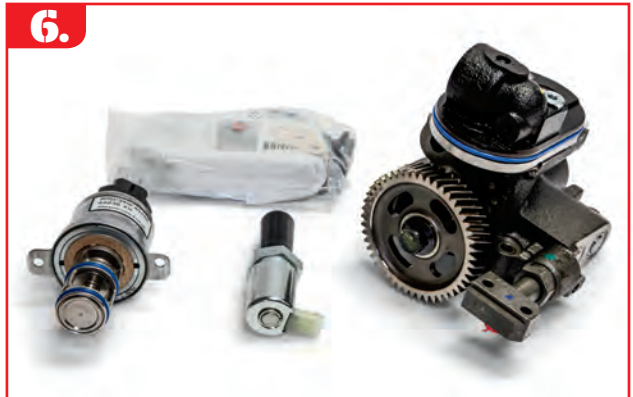
6. The HPOP was what started all this in the first place, so we ordered one from Ford through Sinister. Unfortunately, we're showing you the late '04 pump and we needed the early one, which delayed our start time a couple days. The EGR Valve and IPR were ordered up as well. Again, every gasket, seal, and O-ring that came off was replaced with a new part as well.

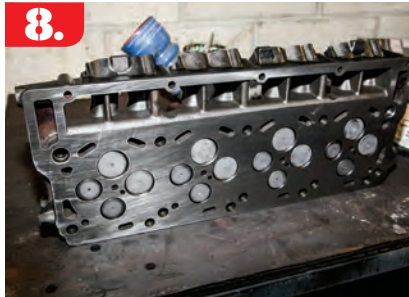
8. Since we were going this far, we opted to spend the extra money with Bud's for a set of their rebuilt and resurfaced cylinder heads with a fresh valve job. They were bagged and waiting for us to bolt on!

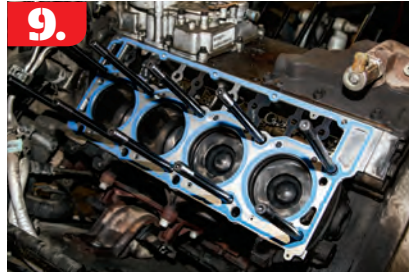
9. Reassembly begins with applying some ARP Ultra-Torque lubricant to each of the ARP studs and threading them into the block. Studding the block is a great first step in bulletproofing our Power Stroke. The new head gaskets were then set over the studs.

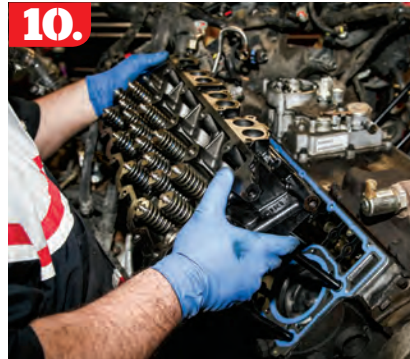
10. Once the studs were torqued to spec we set the heads into place.

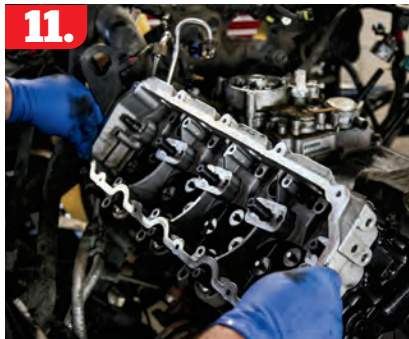
11. Next, we set the rocker carriers in place over the heads, and reinstalled the cleaned-up pushrods and rocker assemblies.

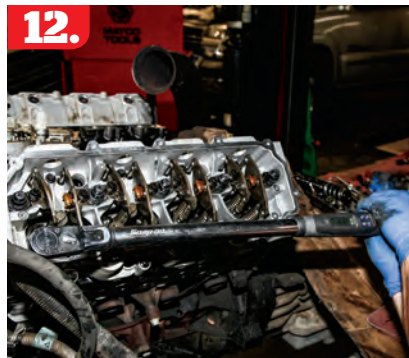
12. Now all of the nuts and bolts were torqued to their respective values.

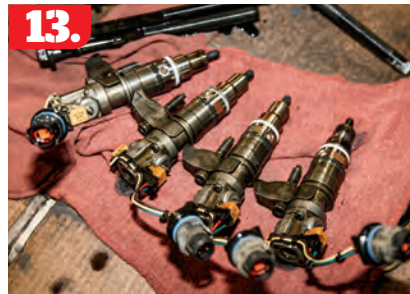
13. Bud's crew did comprehensive diagnostic testing when we brought the truck in, and determined all the injectors to be in good working order, so they were cleaned up and reused.

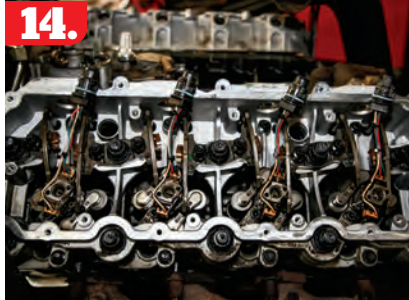
14. We dropped the injectors into place, and were almost ready to button up the valvetrain.

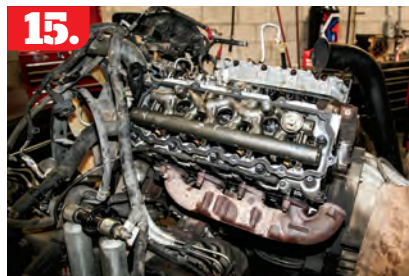
15. The high-pressure oil rails were reinstalled next, and as always, torqued to spec. We also reinstalled the exhaust manifolds at this time. As soon as the valve covers were cleaned up, they were reinstalled, too.

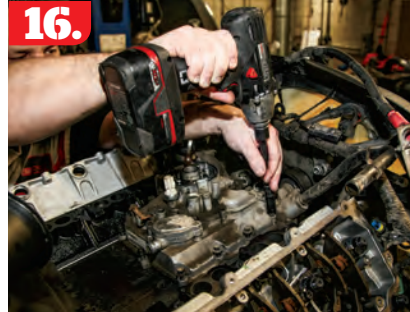
16. Moving our bulletproofing elsewhere on the engine, we removed the oil cooler housing from the engine valley.

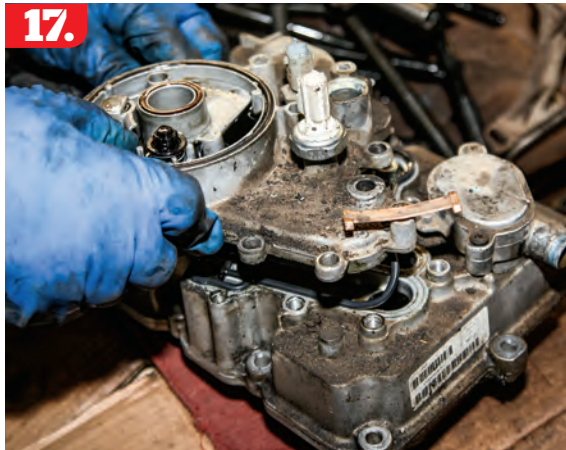
17. Now the oil filter base was removed from the cooler housing and cleaned up.

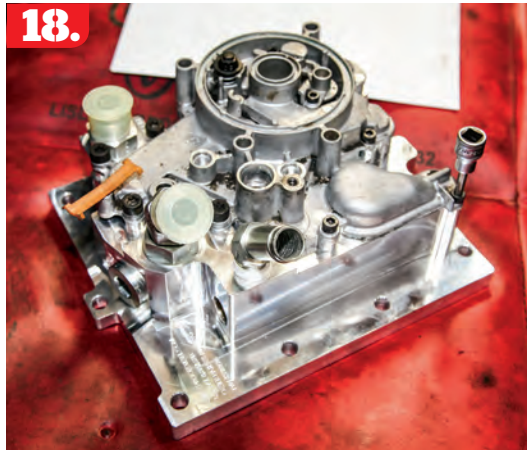
18. With all the new seals in place, the filter housing is bolted up to the Bullet Proof Diesel Billet Oil Transfer Block using both new and existing hardware.

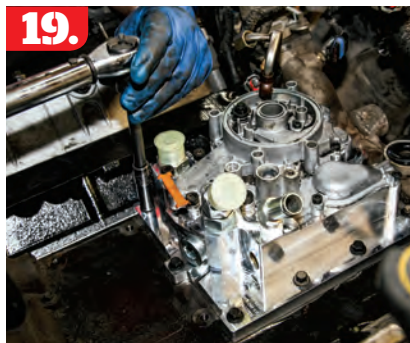
19. With no oil cooler down below, the new assembly was bolted back in place in the engine valley.

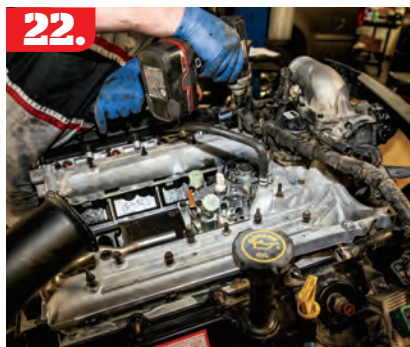
22. Using all the new seals, the intake manifold assembly was now bolted into place.

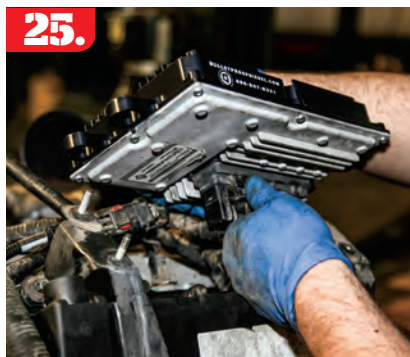
25. The now-bulletproof FICM was bolted into place above the left valve cover.

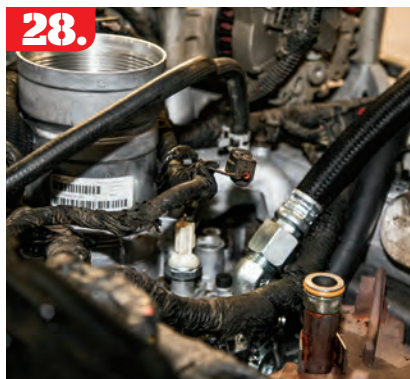
28. From here we can begin to route the oil cooler lines over toward the passenger fender where the cooler will be located.

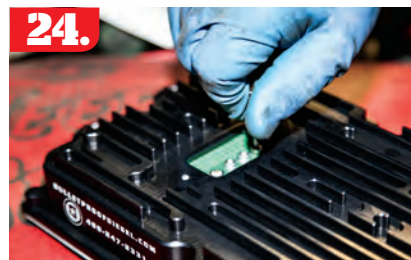
24. The stock FICM was split in half, and OE bottom half was attached to the Bullet Proof Diesel billet top section. These heavy-duty FICMs can be bumped up from 48 volts to 53 or 58 volts, but shown here, we are adjusting them to the stock output.

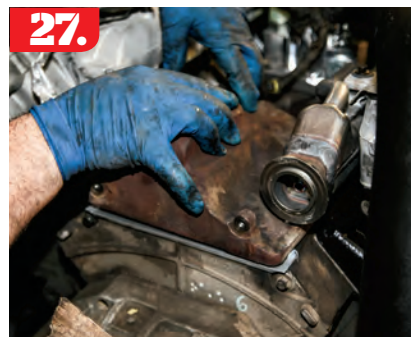
27. With the new seals in place, the pump cover is reinstalled and torqued to spec.

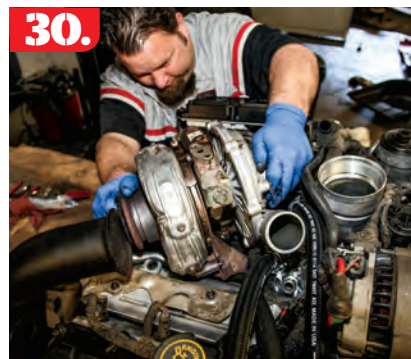
30. With the turbocharger looking better than new we buttoned it back up and reinstalled it on the turbo pedestal. At this point, the cab is dropped back down and all of the electrical is reconnected. We're in the home stretch now.

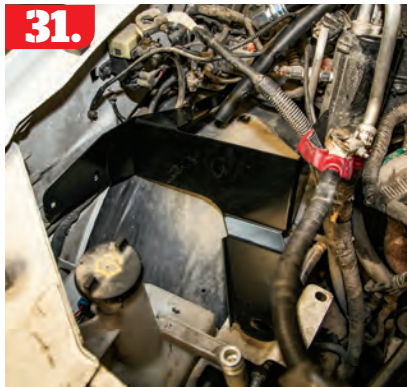
31. For the oil cooler relocation, the stock vacuum reservoir was removed, and the mounting bracket was installed using three vibration isolators.

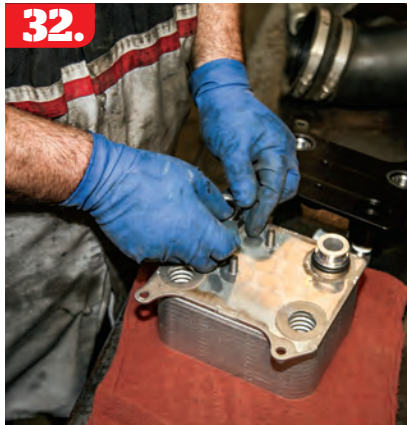
32. The brand-new, factory-style oil cooler was prepped with all new seals.

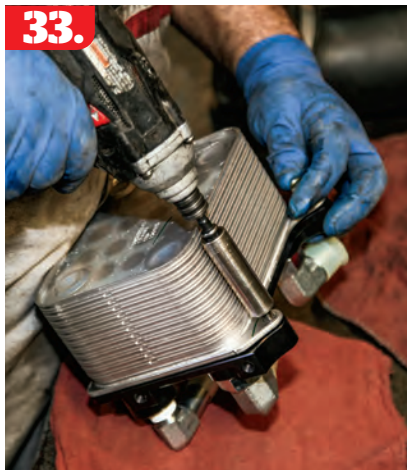
33. Now the cooler was bolted up to the relocation plate.

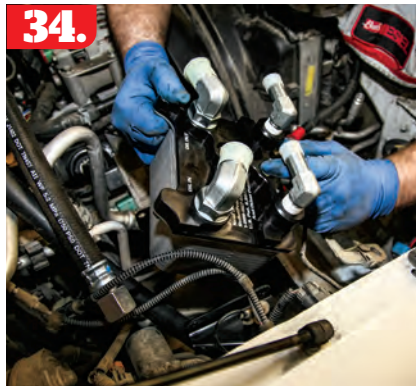
34. The complete assembly was then bolted into the mounting bracket.

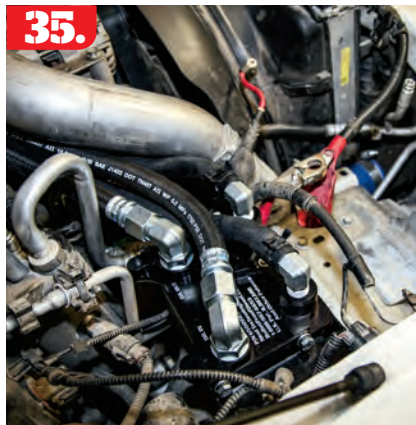
35. Finally, the oil and coolant lines were routed and installed.

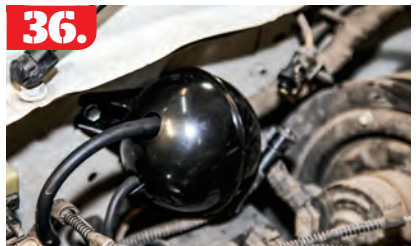
36. A new, compact vacuum reservoir is bolted into a stock hole on the inner fender.

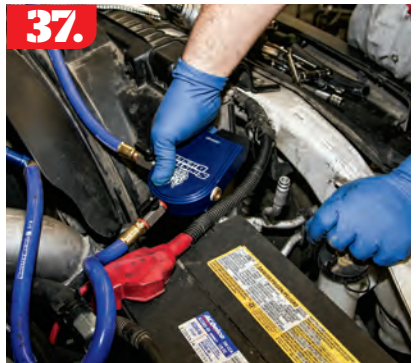
37. The battery tray and battery were returned to their original location. Then the Sinister Diesel Coolant Filter Kit was installed. The filter base bracket bolts over an existing stud on the core support.

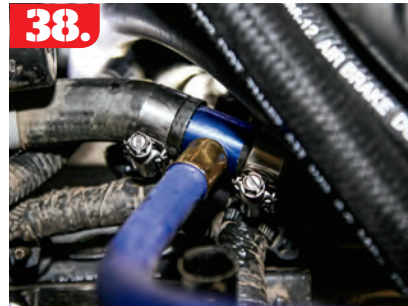
38. The filter lines were then tapped into the coolant lines as per the instructions.

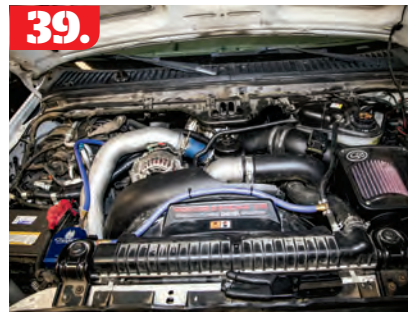
39. At this point, the filter and cooler lines were completed, new fluids were added, and a thorough inspection of the engine compartment was made. With the checklist complete, the truck was fired up!

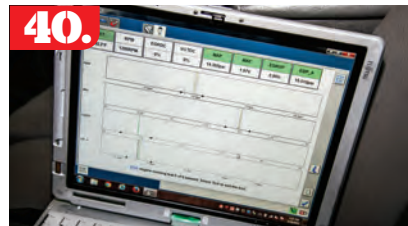
40. Even before a test drive, the diagnostic computer was hooked up and the SCT tune was reinstalled. We got a clean bill of health, except for a weird hesitation off the line. We quickly found the culprit—a bald wire on a switch to the transmission, most likely caused by yours truly climbing all over the chassis to get shots of the top of the engine.

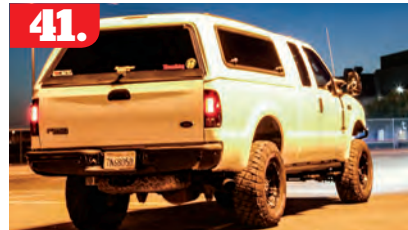
41. With that mystery solved, we did some extensive testdriving, namely, 2,000 miles at the NORRA 1000 in Baja. We didn't really add horsepower (although it sure felt like it), but now we were more than confident we could use the available power and maintain reliability for years to come!
