# POWER STROKE BULLETPROOFING TACTICS

## Part 1: What it takes to make a 6.0L reliable

Upgrades and troubleshooting strategies for this truck are numerous. One company that specializes in all things Power Stroke is Bulletproof Diesel of Mesa, Arizona. The company's owners, brothers Ken and Gene Neal, have invested a ton of time and money into resolving problems associated with the 6.0L. As the name implies, Bulletproof Diesel products circumvent expensive repairs and costly downtime while providing the reliability that Super Duty owners expect from their trucks. We put their upgrades to the test recently on a friend's '04 F-350 dually. Check out what we discovered.

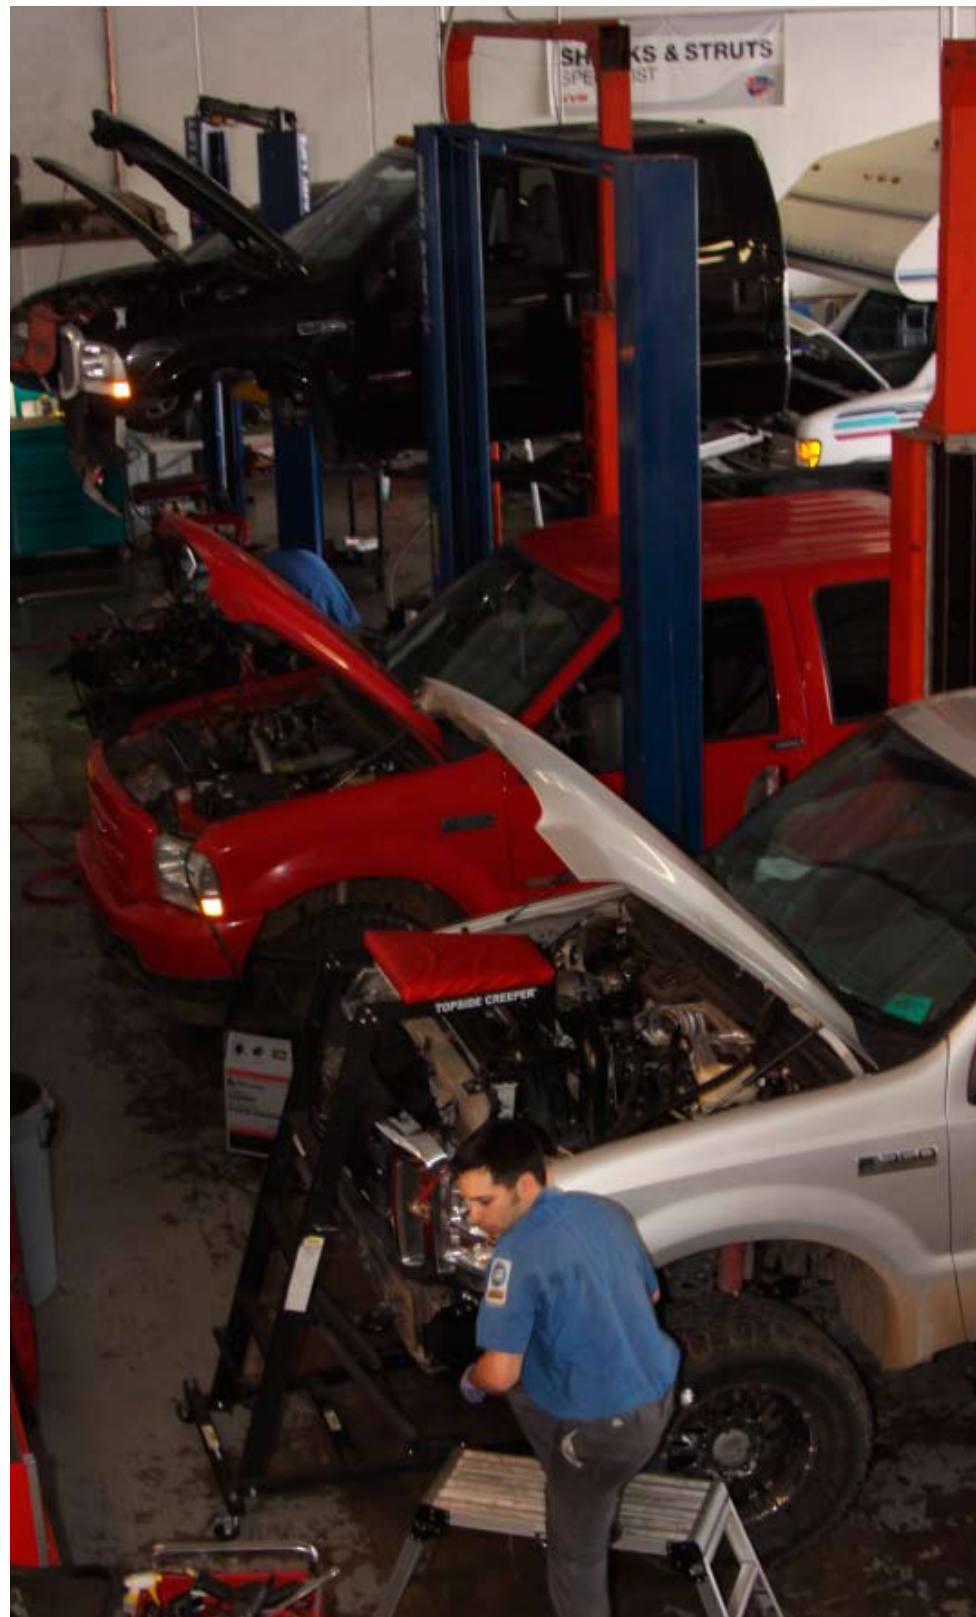
► Inside Bulletproof Diesel's Mesa facility: Each week, three to five 6.0L-powered Super Duty pickups cycle through the shop receiving a plethora of upgrades that ensure long engine life and improved power and efficiency. In virtually every case, Bulletproof's technicians must remove the cab from the chassis to gain access to the critical areas of the engine compartment. While this may seem like a lot of work initially, remember that it took Bulletproof less than one hour to complete this procedure on our donor truck.

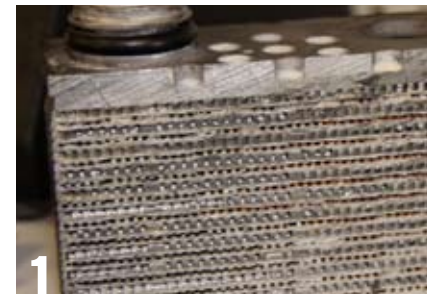
► This diagram shows how engine oil moves within the 6.0L Power Stroke engine. Notice the absence of an external cooling device.

1 The 6.0L Power Stroke engine has a unique oil temperature regulation system that relies on engine coolant to raise or lower oil temperature within a given operational range. The system utilizes a compact aluminum heat exchanger that is located in the front of the engine, just under the oil filter assembly. The 6.0L engine block features a void that allows the cooler to mount inside the "V" of the engine. The self-contained stacked-plate heat exchanger is highly effective when the engine is new. However, over time the narrow interior passageways can become restricted by corrosion, debris in the coolant, and casting sand left over from the manufacturing process. This picture shows a cooler that Bulletproof Diesel cut in half with a bandsaw. Despite having roughly 45,000 miles on it, this unit was compromised. Notice the discolored areas in the passageways between the fins; this is the material that creates the restriction. When this happens, coolant flow is significantly impacted. If left unchecked, this lack of coolant flow creates a domino effect that eventually leads to catastrophic engine failure.

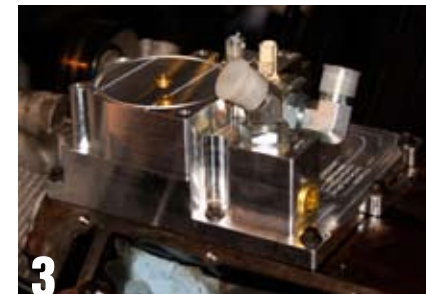
3 At the heart of Bulletproof Diesel's 6.0L oil system upgrade is a trick billet aluminum transfer block. The unit completely replaces the factory cast aluminum oil filter housing. In doing so, engine oil is redirected to the front of the vehicle where a large aluminum cooler and filter assembly further improve upon the factory design. This block is manufactured on a CNC mill to specific design tolerances established by the engineers at Bulletproof Diesel. To the best of our knowledge, nobody else offers a unit of this kind. We like the fact that the transfer block utilizes the OE gaskets and hardware to retain the assembly to the engine. Once the cab of the vehicle is free from the chassis, the installation of the transfer block is a simple bolt-on affair.

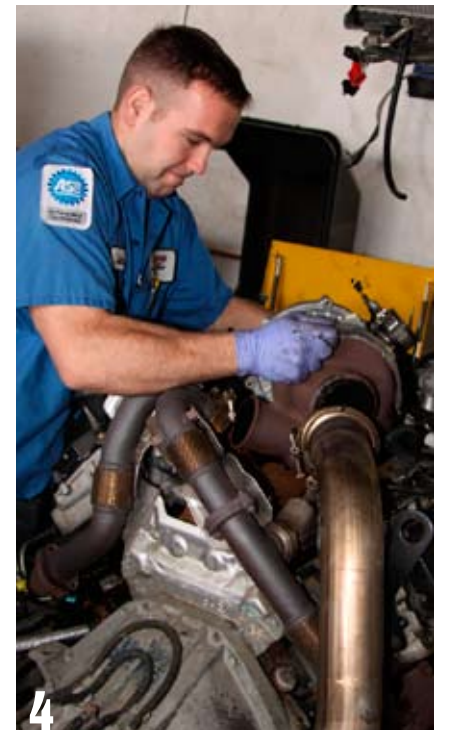
4 Here, you can see Bulletproof Diesel's ASE certified technician, Justin Aguirre, removing the turbocharger from the top of the engine. This is the first step in the process of disassembly. If the cab of the truck were still attached to the chassis, this procedure alone might take half a day to complete. Instead, Aguirre had our donor truck's engine completely stripped down to a bare block in the same time frame.

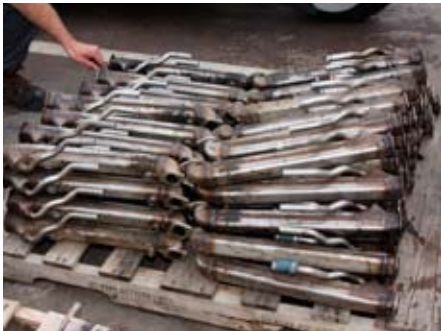
▷ This is where most failed EGR coolers eventually end up. Bulletproof Diesel purchases these failed units from repair shops throughout the country. They rebuild them and resell them as Bulletproof EGR coolers.

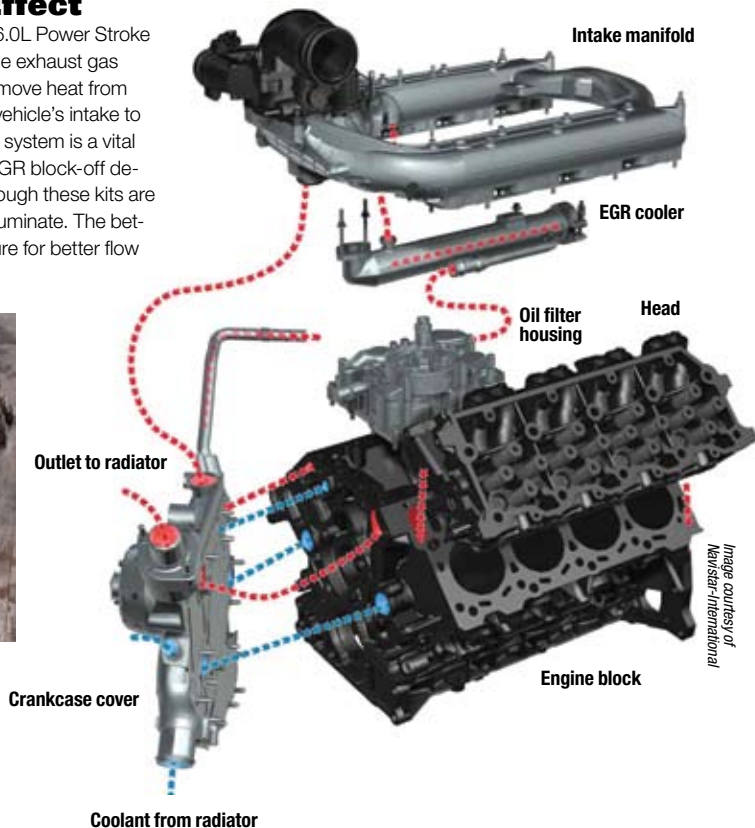
The illustration to the right details how coolant moves through the 6.0L Power Stroke engine. Notice that after coolant leaves the oil cooler, it flows to the exhaust gas recirculation (EGR) cooler. The EGR cooler uses engine coolant to remove heat from a portion of the spent exhaust gases as they're directed back to the vehicle's intake to help reduce the creation of NOx (nitrogen oxide) emissions. The EGR system is a vital component of the emissions control system. Some companies sell EGR block-off devices that eliminate the functionality of the EGR system altogether, though these kits are for off-road use only and typically cause the "check engine" light to illuminate. The better solution is a Bulletproof EGR cooler with an improved core structure for better flow characteristics.

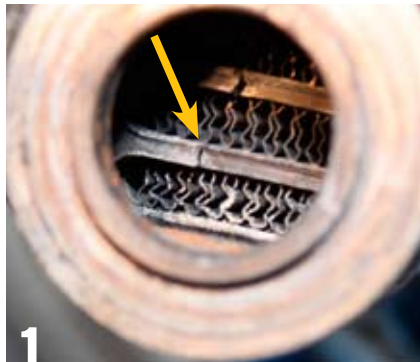
❶ This is an example of a failed EGR cooler that caused a catastrophic engine failure. Notice the cracked coolant passageway (arrow). This unit failed because of a clogged oil cooler and excessive exhaust gas temperatures. This type of failure is typically caused by running an aggressive tuner or chip on a 6.0L with coolant flow issues. You see, the EGR cooler is the next place engine coolant goes after leaving the factory engine oil cooler. When the coolant side of the oil cooler is restricted, the EGR cooler cannot cool hot exhaust gases effectively. The EGR cooler was never designed to handle extreme heat and therefore develops a rupture or crack. When this type of failure occurs, coolant will mix with exhaust gases inside the EGR cooler—not good.

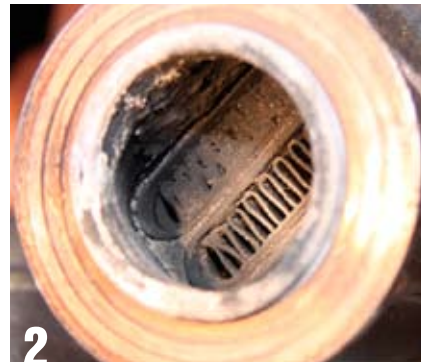
❷ This photo shows the other type of EGR failure that Bulletproof Diesel encounters regularly. Exhaust gases deposit gunk on the cooling fins inside the EGR cooler. This causes restriction within the unit. This restriction cuts down on the EGR's effectiveness, allowing higher exhaust gas temperatures to reach the intake manifold. Generally, this type of failure can be traced back to a clogged engine oil cooler. As the coolant side of the oil cooler becomes restricted, less heat is scavenged from the engine oil. This results in higher coolant temperatures and a lower volume of coolant exiting the oil cooler. As the restricted and hot coolant reaches the EGR cooler, the hot exhaust

gases "flash-boil" the coolant in the adjacent channels of the EGR cooler. This failure usually results in loss of coolant from the coolant reservoir. This condition typically leads to a rupture failure of inside the EGR cooler, and eventually results in blown head gaskets.

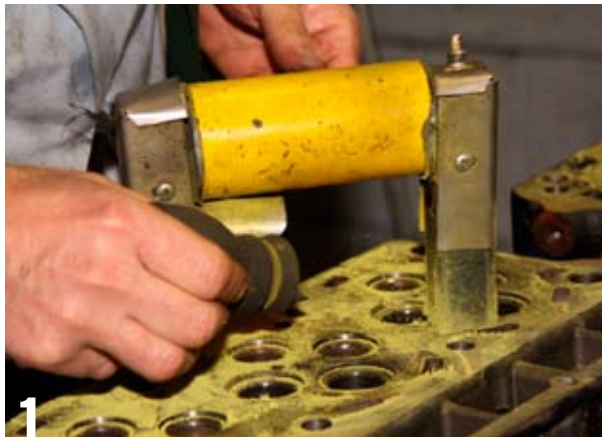
1 Our donor truck had just over 40,000 miles on it when we arrived at Bulletproof Diesel. Despite being completely unmodified, many of the valve seats of the cast-iron heads had developed cracks. While these heads offer great flow characteristics, thanks to having four valves per cylinder, the lack of hardened valve seats makes them prone to premature failure. The porous iron material that was used for the OE heads isn't capable of withstanding the high heat and pressure developed during the combustion process. The result is the formation of small cracks where the valve contacts the machined seat surface. Bulletproof had our donor's heads Magnafluxed to check for cracking. Magnafluxing is a process whereby an electromagnetic field is applied to the material, in this case the cast-iron heads. Once the magnetic field is applied, a small amount of colored metallic dust is spread over the magnetized area.

When the metallic dust meets the surface, it reveals cracks immediately, thanks to interruptions in the

magnetic field. This inspection method allows very small cracks to be visible to the naked eye.

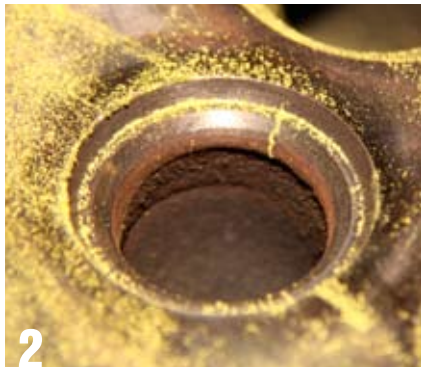
2 This close-up view shows one of the many cracks found in the valve seats of our donor's heads. If not addressed, these cracks can result in loss of compression, decreased power, and increased fuel consumption. If neglected entirely, these cracks eventually grow large enough to damage valvetrain components, and in some cases, they can actually lead to catastrophic engine failure.

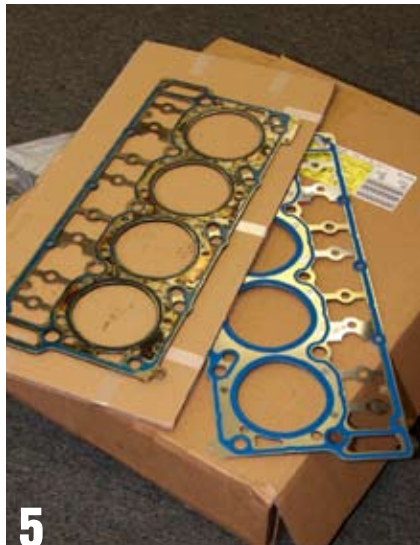
5 Anytime you remove the heads from an engine, it is a good idea to replace the head gaskets. We sourced a pair of genuine Ford/Motorcraft replacement gaskets from Stephan Eschrich at Berge Ford in Mesa, Arizona, which supplies Bulletproof Diesel with these kits. Aftermarket head gaskets exist, though the type that Ford supplies are preferred because they include a pair of redesigned high-pressure standpipes with built-in check valves to improve engine starting. The multi-layer steel head gaskets feature five individual steel plates that are riveted together, along with a special blue sealant to resist high pressure and extreme heat.

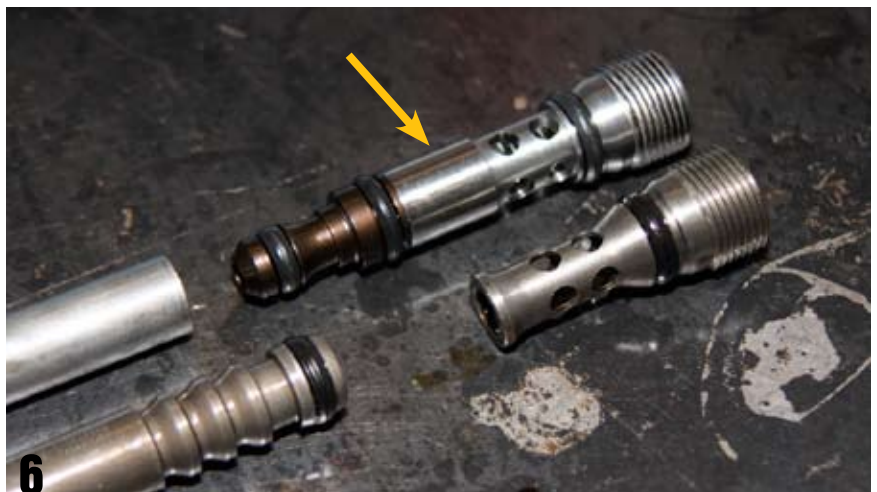
6 This photo shows both the old- (pre-'05) and new-style ('05-and-later) high-pressure oil stands for the 6.0L lubrication system. Notice that the new version (top) includes an integrated check valve (arrow). The primary function of these metallic tubes is to deliver engine oil discharged from the high-pressure oil pump to each of the two high-pressure oil rails on top of each cylinder head. The improved versions retain engine oil at the top of the engine to help the system reach operational pressure as soon as you turn the key. This upgrade reduces the total number of rotations it takes to start the engine—another commonly reported problem with the 6.0L. These pipes are a factory retrofit and are automatically included with all new 6.0L head gasket kits from Ford.

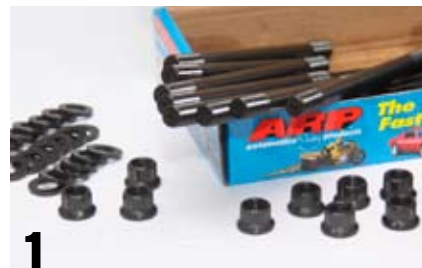
1 ARP is a leader in high-quality automotive fasteners worldwide. Manufactured in Southern California, ARP stud kits are cheap insurance against fastener-related engine failures. Thanks to extensive quality control, even prior to their manufacturing efforts, ARP has earned a reputation for zero failures across all product lines. We picked up ARP's head stud kit (p/n 250-4202) as well as a tube of ARP Ultra-Torque, a lubricant designed to help fasteners reach a desired torque specification in the first pull.

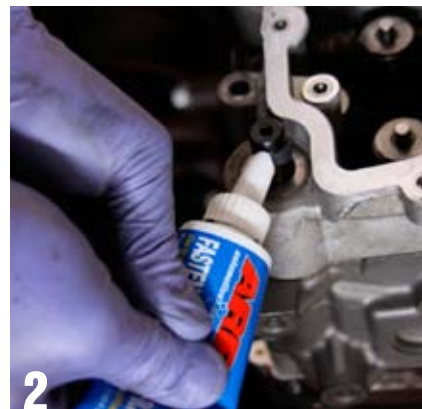
2 Ultra-Torque is specially formulated to reduce the friction between fastener threads. The toothpaste-like substance is easy to apply and use. It significantly reduces seizing and galling of threads, and ensures longevity of the fasteners it touches.

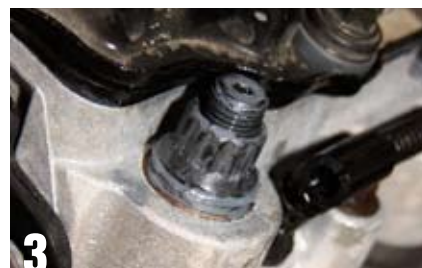
3 After installing ARP head studs.

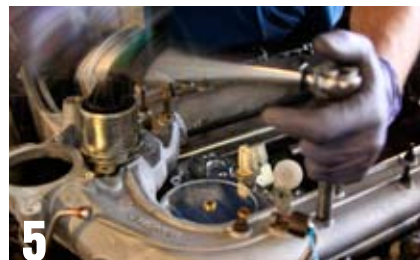
5 When it was time for reassembly, Bulletproof's technicians took great care to ensure that every fastener was tightened to the proper torque spec and in the correct sequence. This kind of attention to detail goes a long way when you consider how easy it is to destroy expensive parts such as the cast aluminum intake manifold shown here. This manifold required a specific two-part sequence and just 8 ft-lb of torque to fasten. Anything more could easily crack the part.

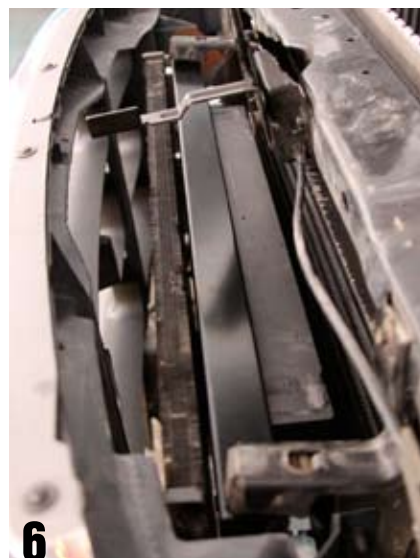
6 Here you can see the Bulletproof Diesel air-to-oil cooler unit after it was installed in our donor truck. The included mounting bracket spaces the factory air-conditioning condenser away from the core support, leaving just enough space for the new cooler to mount between the intercooler and the condenser.

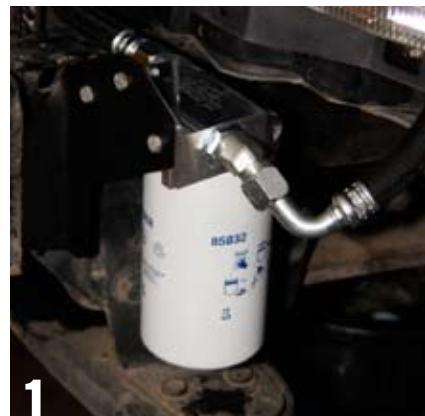
1 With the factory front bumper removed, it's easy to see the location where Bulletproof Diesel relocates the engine oil filter. The system uses a much larger oil filter that, by design, cannot introduce contaminants into the lubrication system as the factory setup often does.

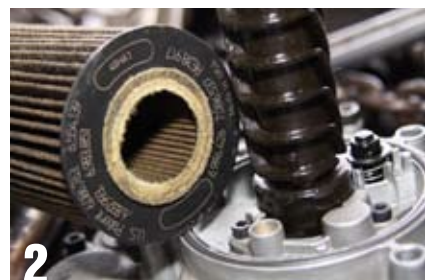
2 Here you can see the felt pad at the bottom of the oil filter element. This design inevitably introduces

particles of felt into the lubrication system. By eliminating this arrangement altogether, Bulletproof Diesel can assure customers that the 6.0L's oil filtration needs are met.

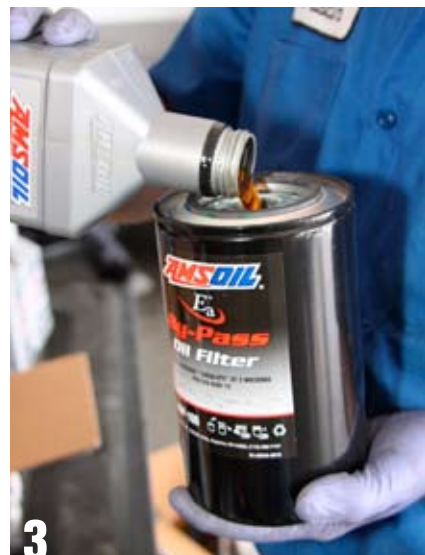
3 Another part that we like about the Bulletproof Diesel oil upgrade is the additional port arrangement included with the system. Thanks to additional pressure and return ports, the system makes it super-easy to add upgrades such as a gauge or auxiliary cooling unit. We took advantage of this opportunity and added a bypass oil filtration device from Amsoil. A bypass oil filter continuously filters a small volume of engine oil whenever the engine is running. Think of it as an automatic oil change every time you drive the vehicle. The bypass filter shown here removes impurities down to 2 microns and leaves your oil the color of honey.

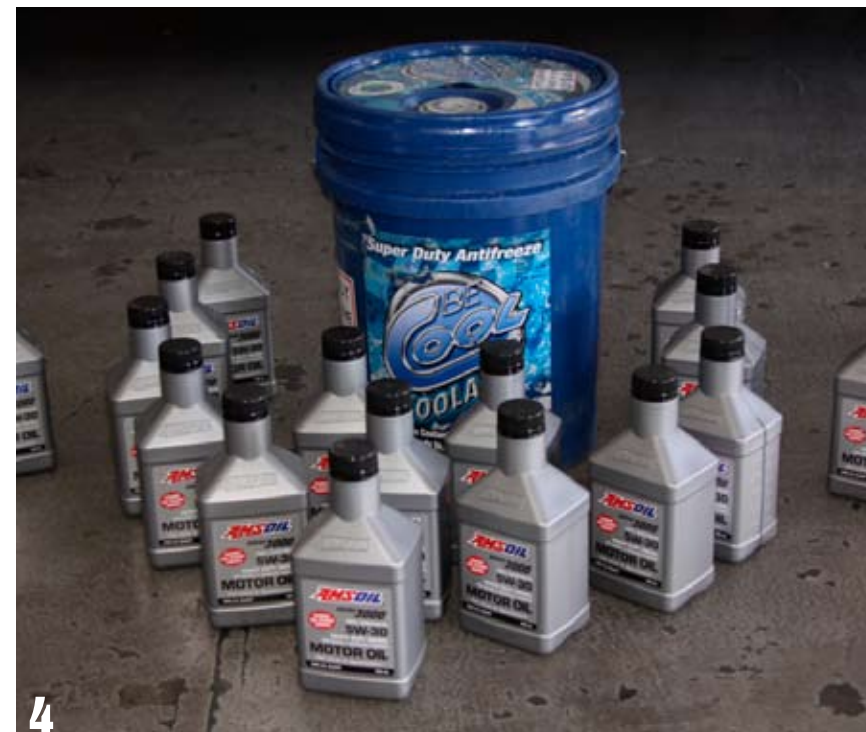
4 We used fully synthetic 5W-30 Amsoil engine oil for this project because it offers superior protection for the various wear surfaces within the 6.0L Power Stroke. We also replaced the engine's antifreeze with the new Super Duty coolant from Be Cool. This coolant comes premixed and ready for use. It is compatible with all types of engine coolant, has a 267-degree boiling point and protects engines for up to 300,000 miles.

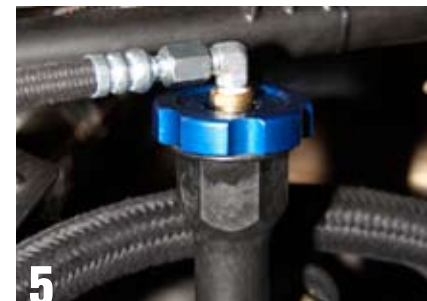
5 The Amsoil bypass filtration system includes a billet aluminum oil cap with a built-in return fitting. We like this setup because it allows you to physically inspect the oil after the bypass oil filter does its job. With the engine idling, you can open the cap and see the clean oil as it is returned to the engine.

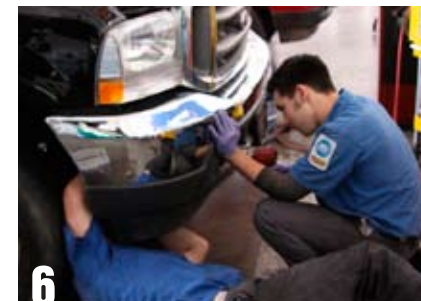
6 With the new Bulletproof Diesel upgrades completed, the technicians reinstalled the factory front bumper and double-checked the fluid levels. A three-hour test drive ensured that the system was functioning properly across a variety of different driving conditions. Needless to say, we left Mesa confident with Bulletproof's work.
